# REMEDIAL ACTION CONTRACT 2 FOR REMEDIAL, RESPONSE, ENFORCEMENT OVERSIGHT, AND NON-TIME CRITICAL REMOVAL ACTIVITIES AT SITES OF RELEASE OR THREATENED RELEASE OF HAZARDOUS SUBSTANCES IN EPA REGION VIII

DRAFT FINAL
CONSTRUCTION COMPLETION REPORT
BEAVER DAM PARK REMEDIAL ACTION
COMMUNITY SOILS OPERABLE UNIT
ANACONDA SMELTER NATIONAL PRIORITIES LIST SITE
ANACONDA - DEER LODGE COUNTY, MONTANA

Work Assignment No.: 346-RARA-0818

June 29, 2012

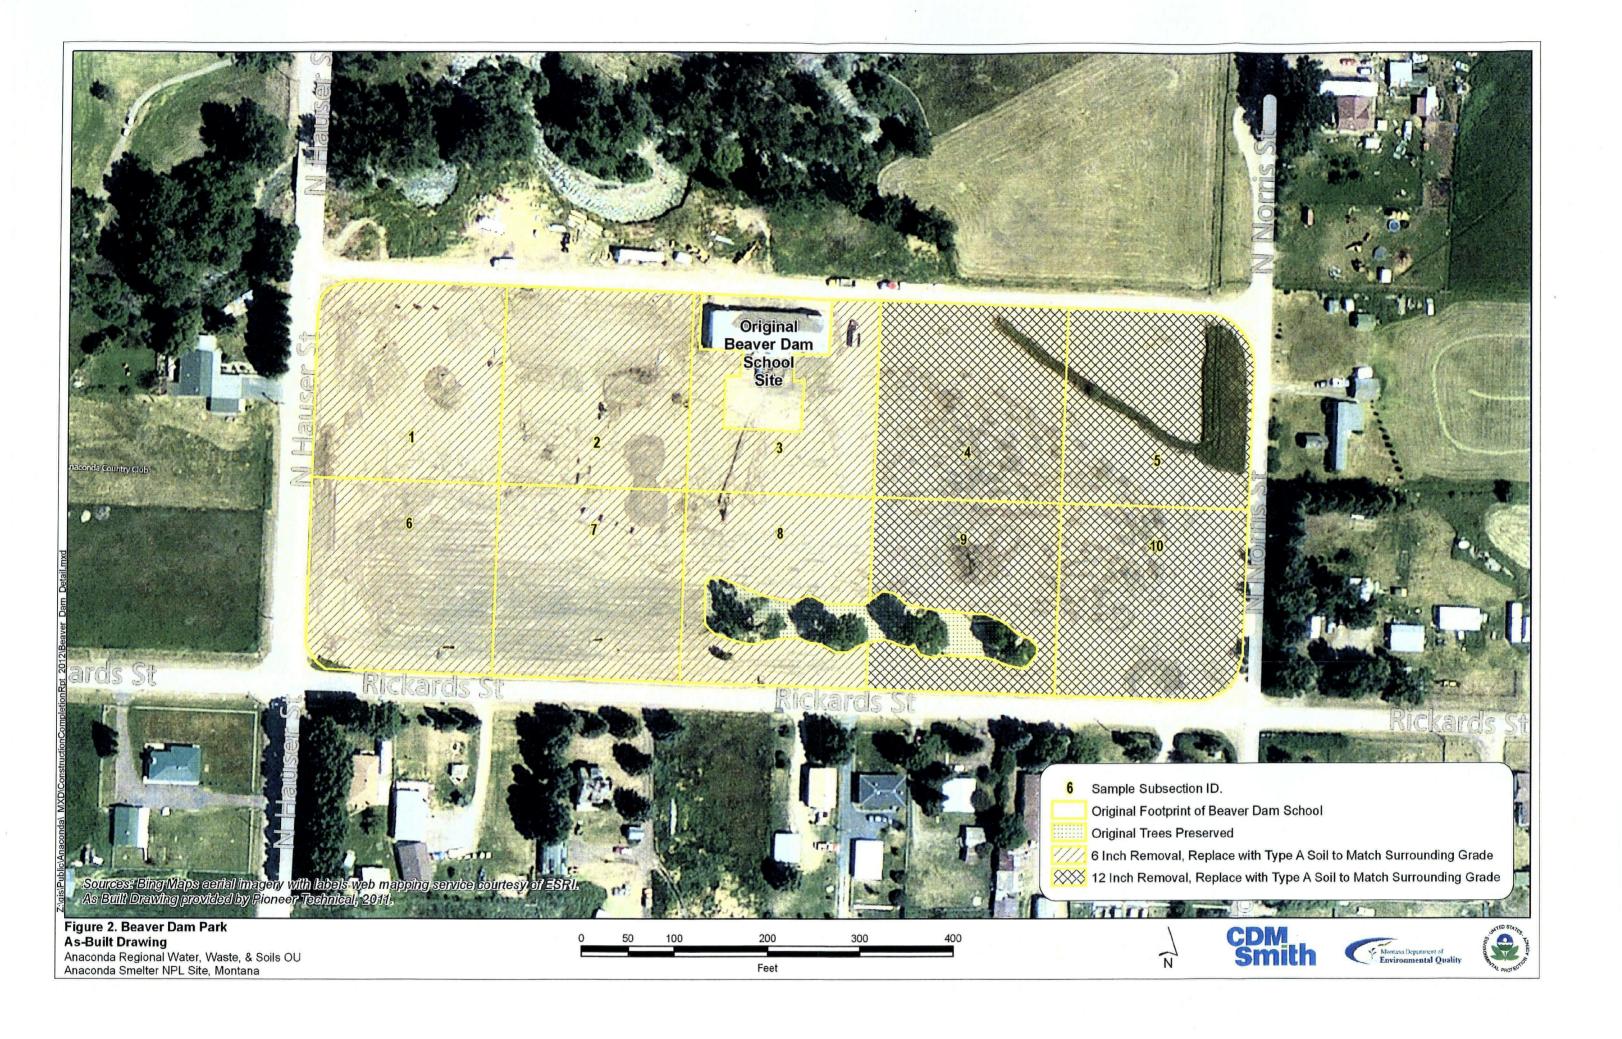
As noted earlier, the Beaver Dam property was to be developed by ADLC into a park under a separate contract. The construction contract contained specific requirements requiring timely completion of the work. Because the construction schedule did not permit time for confirmation sampling, analysis, and additional removal if required, In a March 25, 2011 letter, EPA rejected the ISWP in favor of an over-excavation approach that would not require confirmation sampling after removal was complete. The EPA plan called for removal of the eastern six quadrants to a depth of 6 inches, and removal of the western four quadrants, as shown in Figure 3.

Figure 3 provides a map showing the excavation plan after implementation of the remedy. As such, Figure 3 constitutes the as-built drawing for the site.

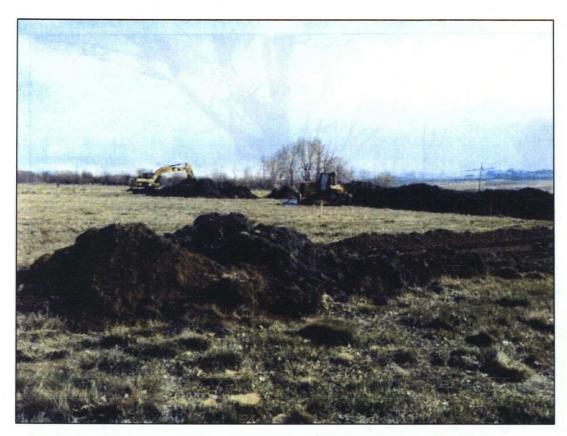
Stripping impacted soils.

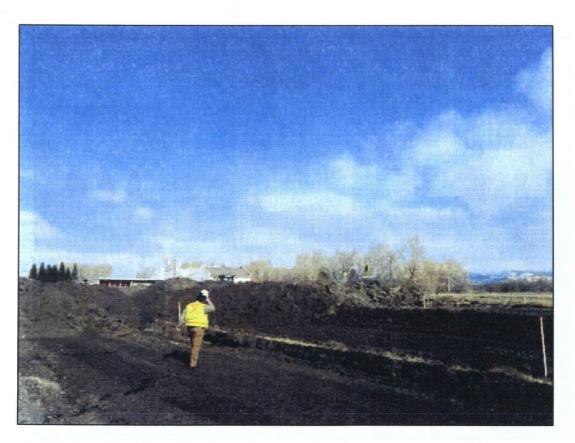
Verifying grade is achieved.

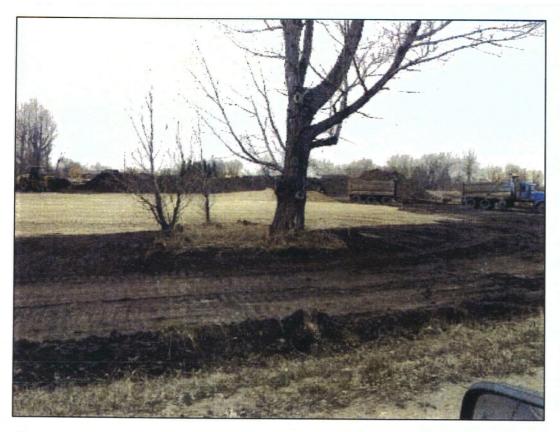
During construction planning, it was decided to leave mature poplar trees along the southern boundary of the property in place (see Figure 3). Similarly, soils in a five foot radius of power lines were also left in place for safety reasons. These areas were left undisturbed during construction with existing vegetation remaining in place.

Preserving mature trees during soil removal.

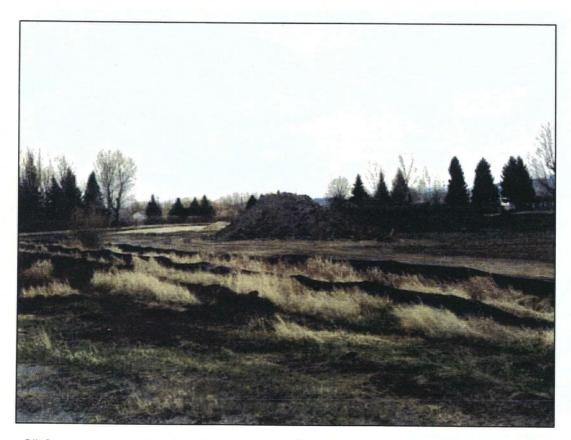
The silt fences were effective in prohibiting runoff from the Beaver Dam Park Site to nearby Mill Creek and drainage ditches , and as best management practices in combination with traffic barricades during non-working hours at the accesses to the site. The silt fences were effective in containing rainfall runoff from the parcel and subsequent mud on public streets. No significant silt build-up or damage to silt fences was noted during use at the Beaver Dam Park Site.

Silt fences were used to prevent sediment runoff into a ditch along the northeast corner of the site.

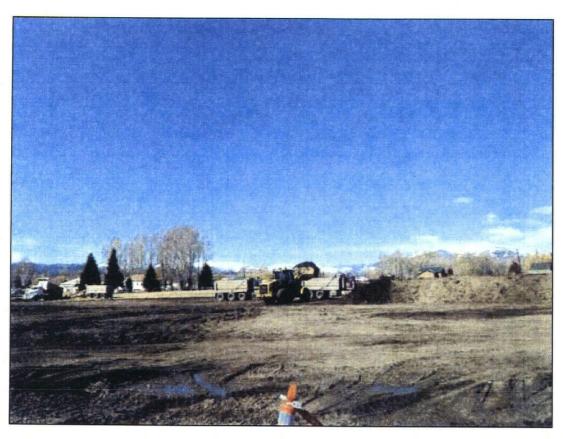
Loading trucks to haul impacted soil to the A.9 cell.

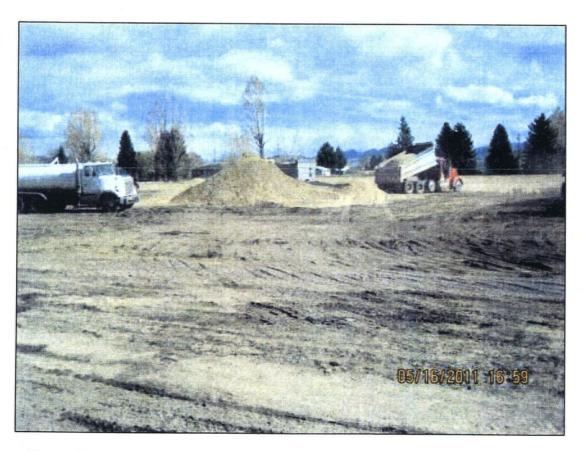
Clean soil being brought in as backfill.
